PROJECT: Midnite Mine Remediation REPORT NO: 2021-21

OWNER: Newmont/Dawn Mining OPERATOR: Newmont/Dawn Mining

### SUMMARY OF WORK ACTIVITIES OR EVENTS FOR THIS REPORTING PERIOD:

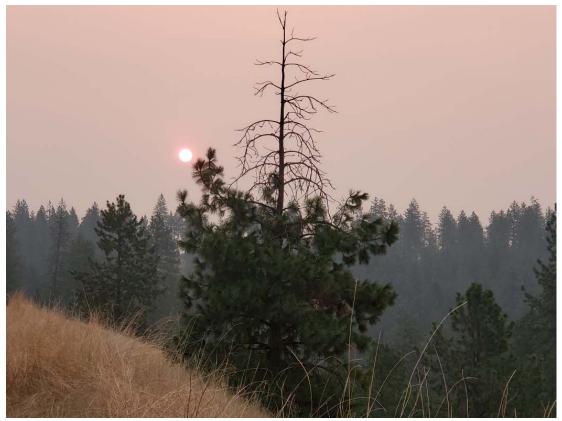
Figure 1 – Smoky site conditions on 13 Aug 2021 looking east from the field offices

- Work was suspended at Site at approximately 3:00 PM on 13 August due to poor air quality. The
  Washington Air Quality Advisory (WAQA) level exceeded 300. Dayshift was cancelled on 16 Aug due to
  the Ford Corkscrew fire. Haul operations were suspended in the afternoon on 17 Aug due to unsafe
  conditions resulting from a rain event (see SWPPP section below).

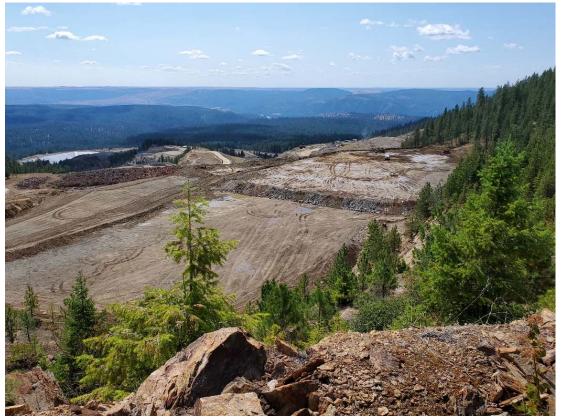
Figure 2 – Overview of Pit 4 – looking south

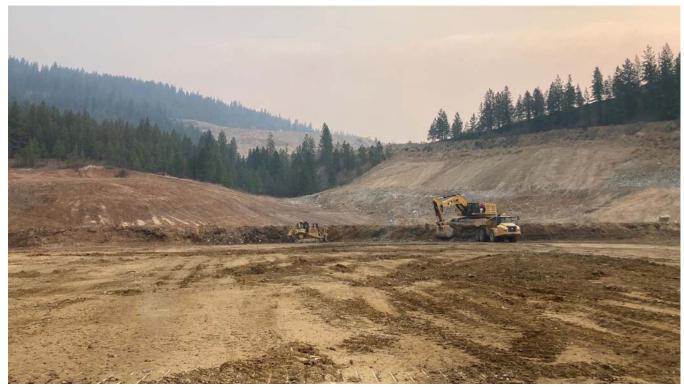
Figure 3 – Excavation, loading and hauling of low activity/low reactivity material from the SWRP, loadout 1 view looking north.

- Newmont excavated, hauled and placed low activity/low reactivity material from the west side of the South Waste Rock Pile (SWRP). Newmont placed these materials in the Pit 4 Waste Containment Area (WCA).

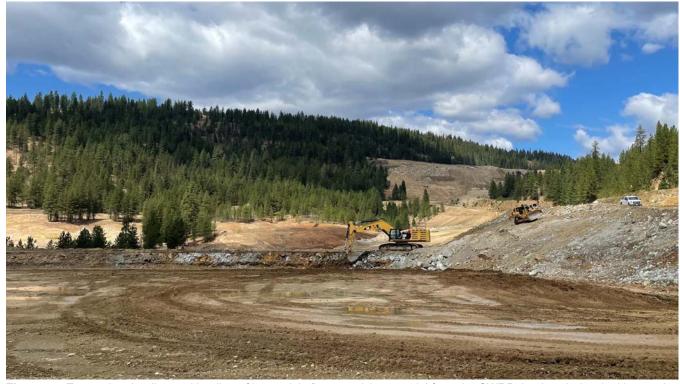
Figure 4 – Excavation, loading and hauling of low activity/low reactivity material from the SWRP, loadout 2 view looking north.

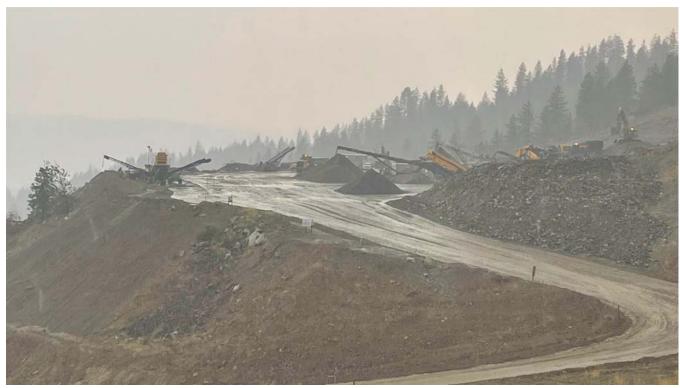
Figure 5 – Crushing and screening operations at the HSWRP view looking west during rain event.

- SLV Earthmovers continued crushing and screening material from the Hillside Waste Rock Pile (HSWRP)
  to produce Drain Gravel and Geomembrane Bedding Material. Newmont hauled these materials to
  stockpile locations designated in the 2021 Crushing and Stockpiling Work Plan (Stantec, 2021).
  Estimated quantities of materials produced are presented in Table 1.

- Newmont halted crushing and screening materials to reevaluate SLV's safety program, reestablish
  exclusion zones, and update SLVs fall protection plan. Re-start criteria given to SLV with a reinspection
  on 23 August.

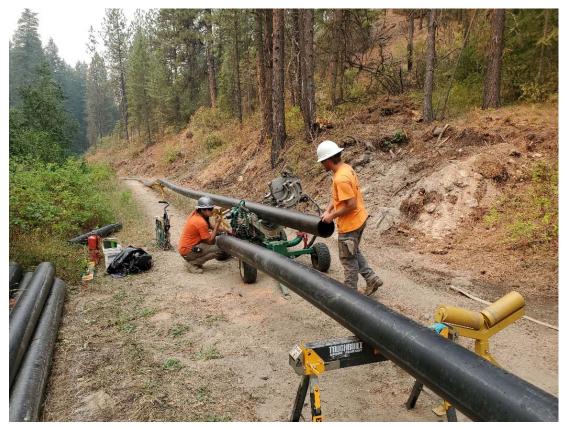
Figure 6 – Halme Construction fusing pipe along Blue Creek Road

- Halme Construction resumed Effluent Pipeline construction activities. Work activities included:
  - Continued fusing pipeline down Blue Creek Road.
